UNDERWATER BRIDGE INSPECTION REPORT

STRUCTURE NO. 30506

STANCHFIELD CREEK

DISTRICT 3 - ISANTI COUNTY

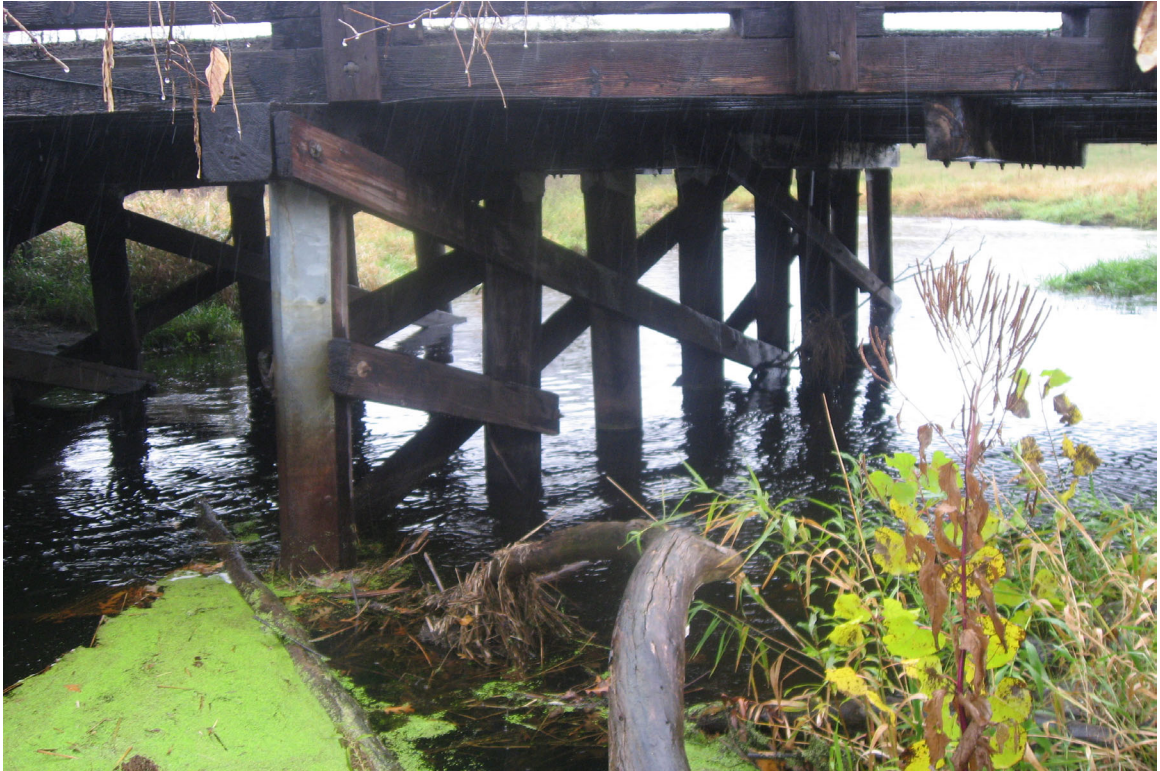
- (A) The timber piles at both piers were in good condition with minor checking up to 1/4 inch in width.
- (B) The upper and lower bracing connection to the easternmost pile of Pier 2 exhibited minor splits which did not affect the connection
- (C) The upstream piles of each pier were protected with a steel ice breaker which exhibited moderate corrosion with rust delamination with up to 1/4 inch thick and pitting up to 1/4 inch in diameter with 1/16 inch deep pitting extending from the channel bottom to 2 feet above the waterline.
- (D) A light accumulation of timber debris consisting of logs and branches up to 8 inches in diameter along with some vegetation was observed at the upstream nose of Pier 1 extending from the channel bottom to 2 feet above the waterline. The accumulation was 15 feet long by 3 feet wide

Photograph 1. View of Pier 1 and Timber Debris, Looking Northeast.

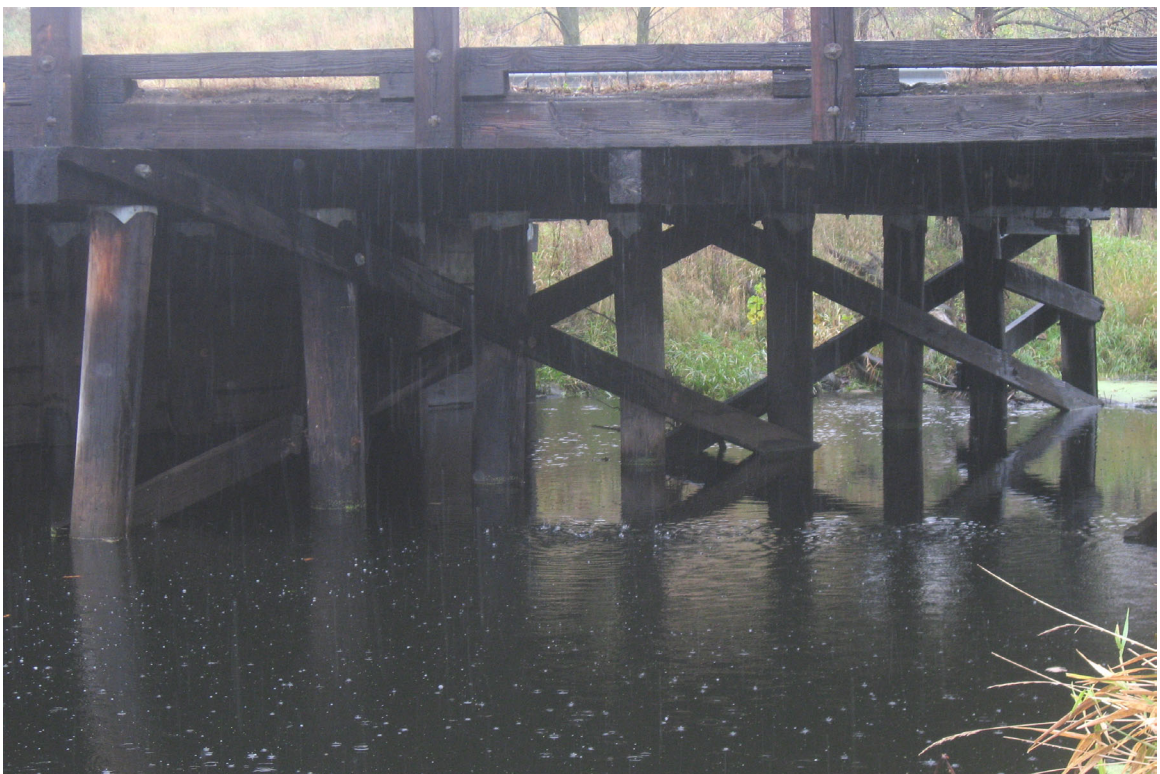
Photograph 2. View of Pier 2, Looking Southwest.

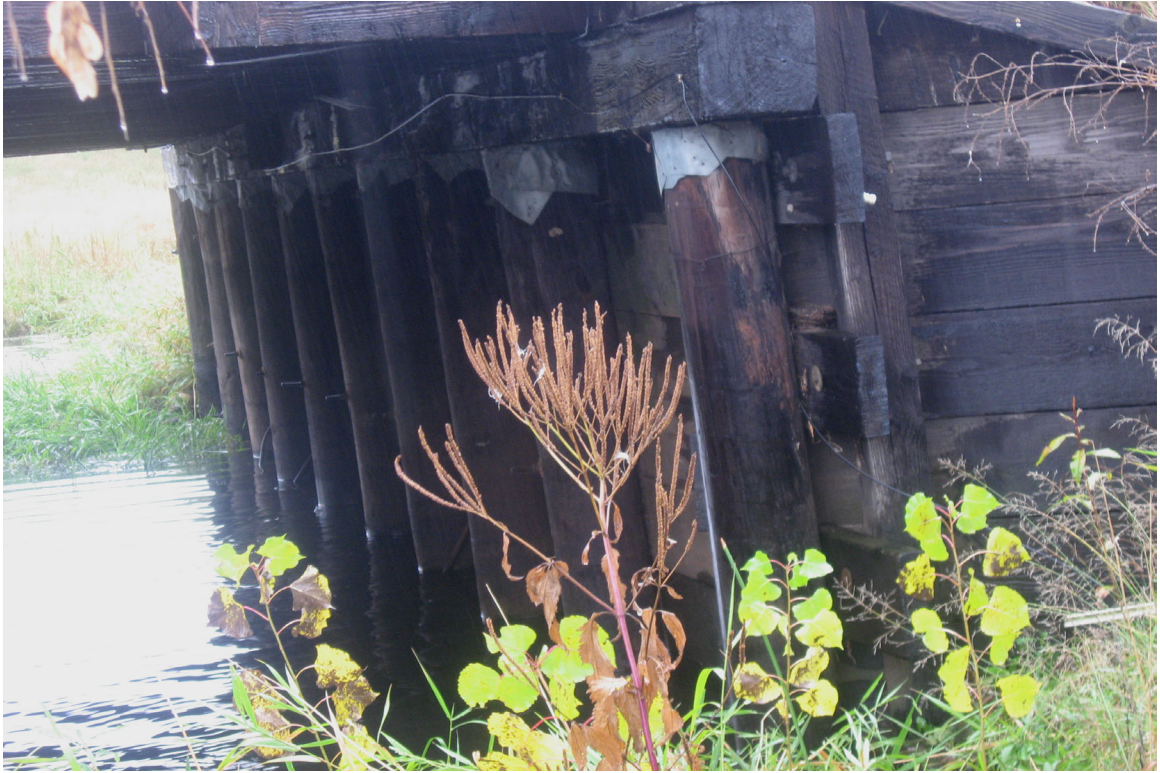
Photograph 3. View of South Abutment, Looking Southeast.

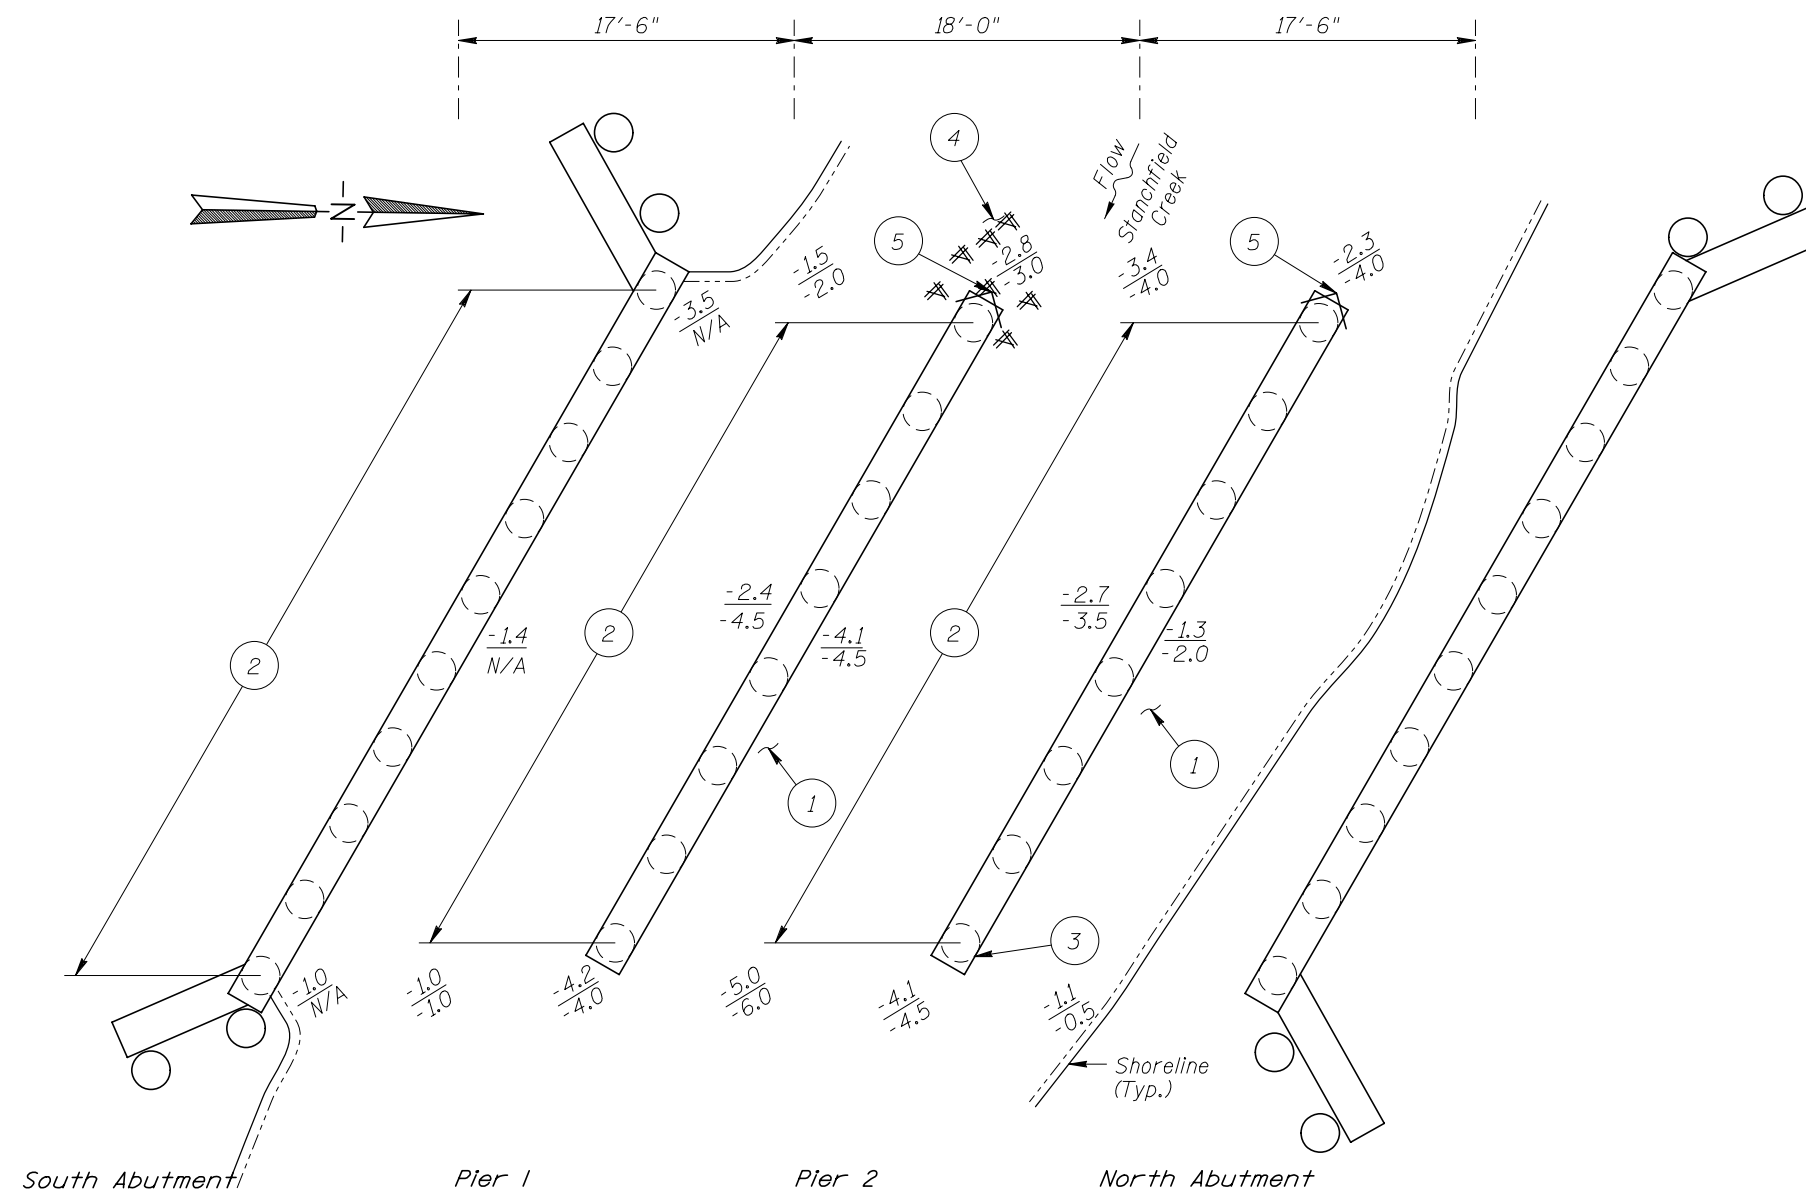
INSPECTION AND SOUNDING PLAN

- The channel bottom consisted silty sand and of 6- to 8-inch-diameter cobbles with up to 1 inch of probe rod penetration.
- The timber piles exhibited minor checking up to 1/4 inch wide.
- The upper and lower cross bracing connection to the easternmost pile of Pier 2 exhibited minor splits.
- A light accumulation of timber debris consisting of 8-inch-diameter and smaller logs along with some vegetation was observed at the upstream end of Pier 1 and extended from the channel bottom to 2 feet above the waterline.
- The upstream piles were protected with a steel ice breaker that exhibited moderate corrosion with rust nodules up to 1/4 inch in diameter with 1/16-inch-deep pitting from the channel bottom to 2 feet above the waterline.
